*California Department of Transportation
Division of Maintenance*

Structure Maintenance and Investigations

Bridge Number : 10 0136
Facility Carried: STATE ROUTE 1
Location : 01-MEN-001-43.74
City :
Inspection Date : 10/06/2015

STRUCTURE NAME: ALBION RIVER

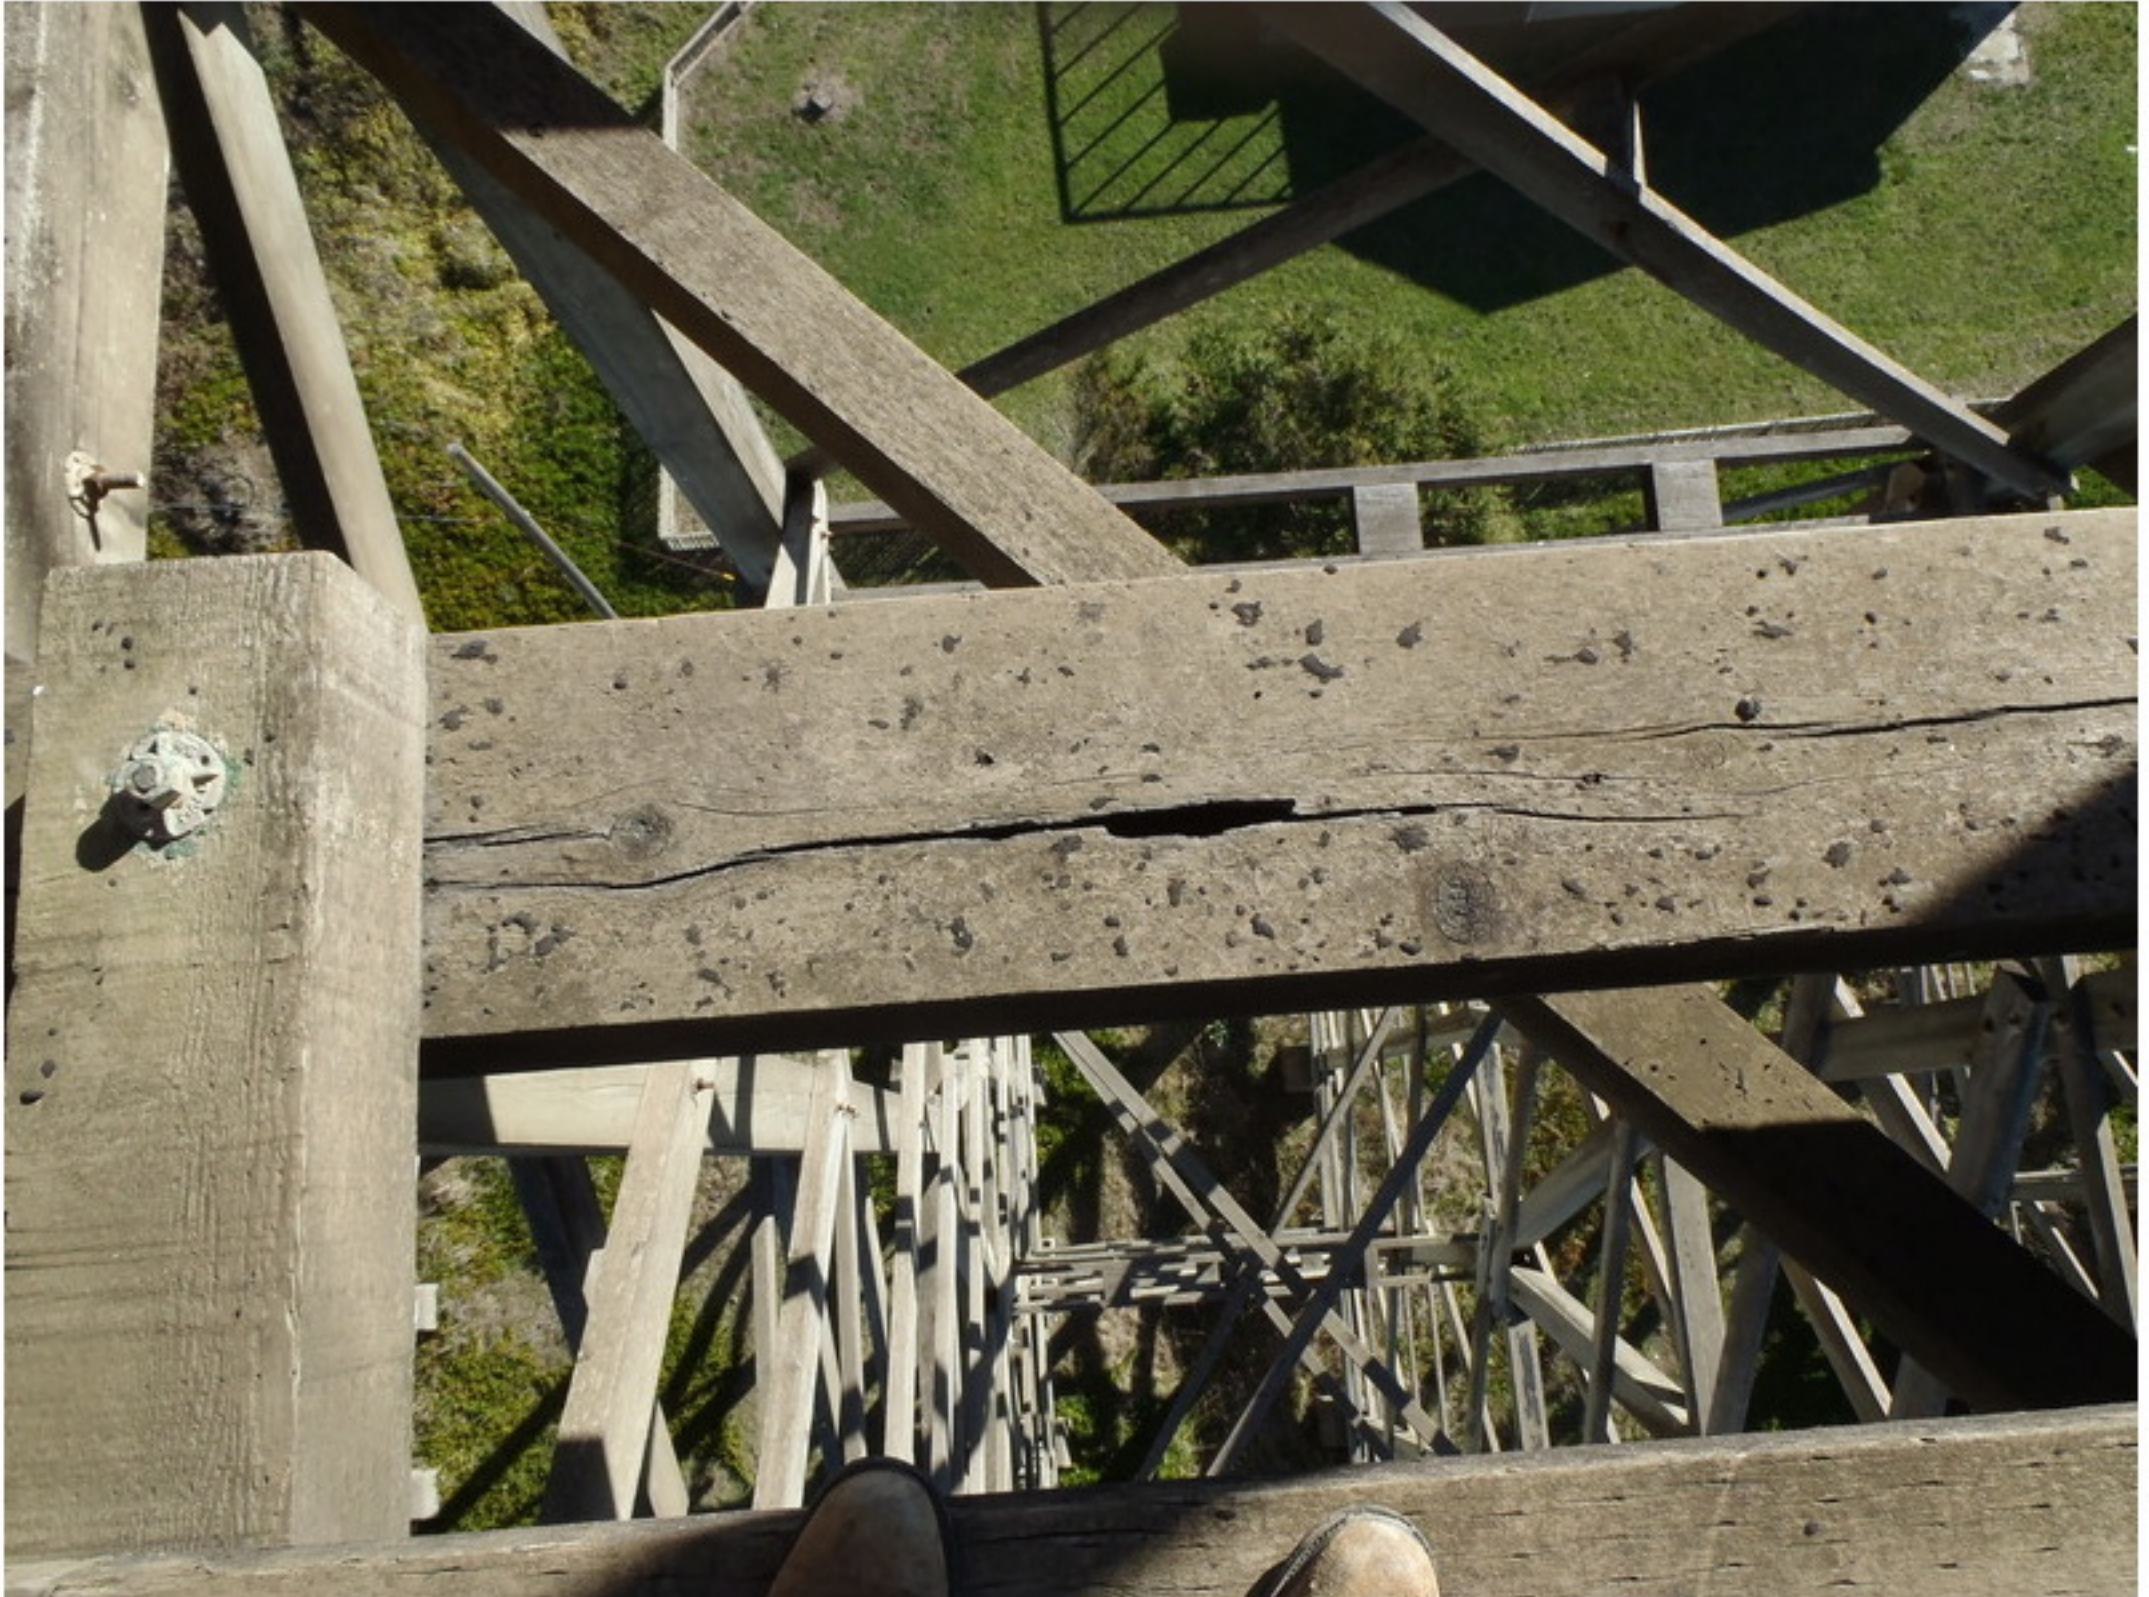
Photo No. 7
Looking down at beam in Span 23 adjacent to Bent 24 - core rot in member

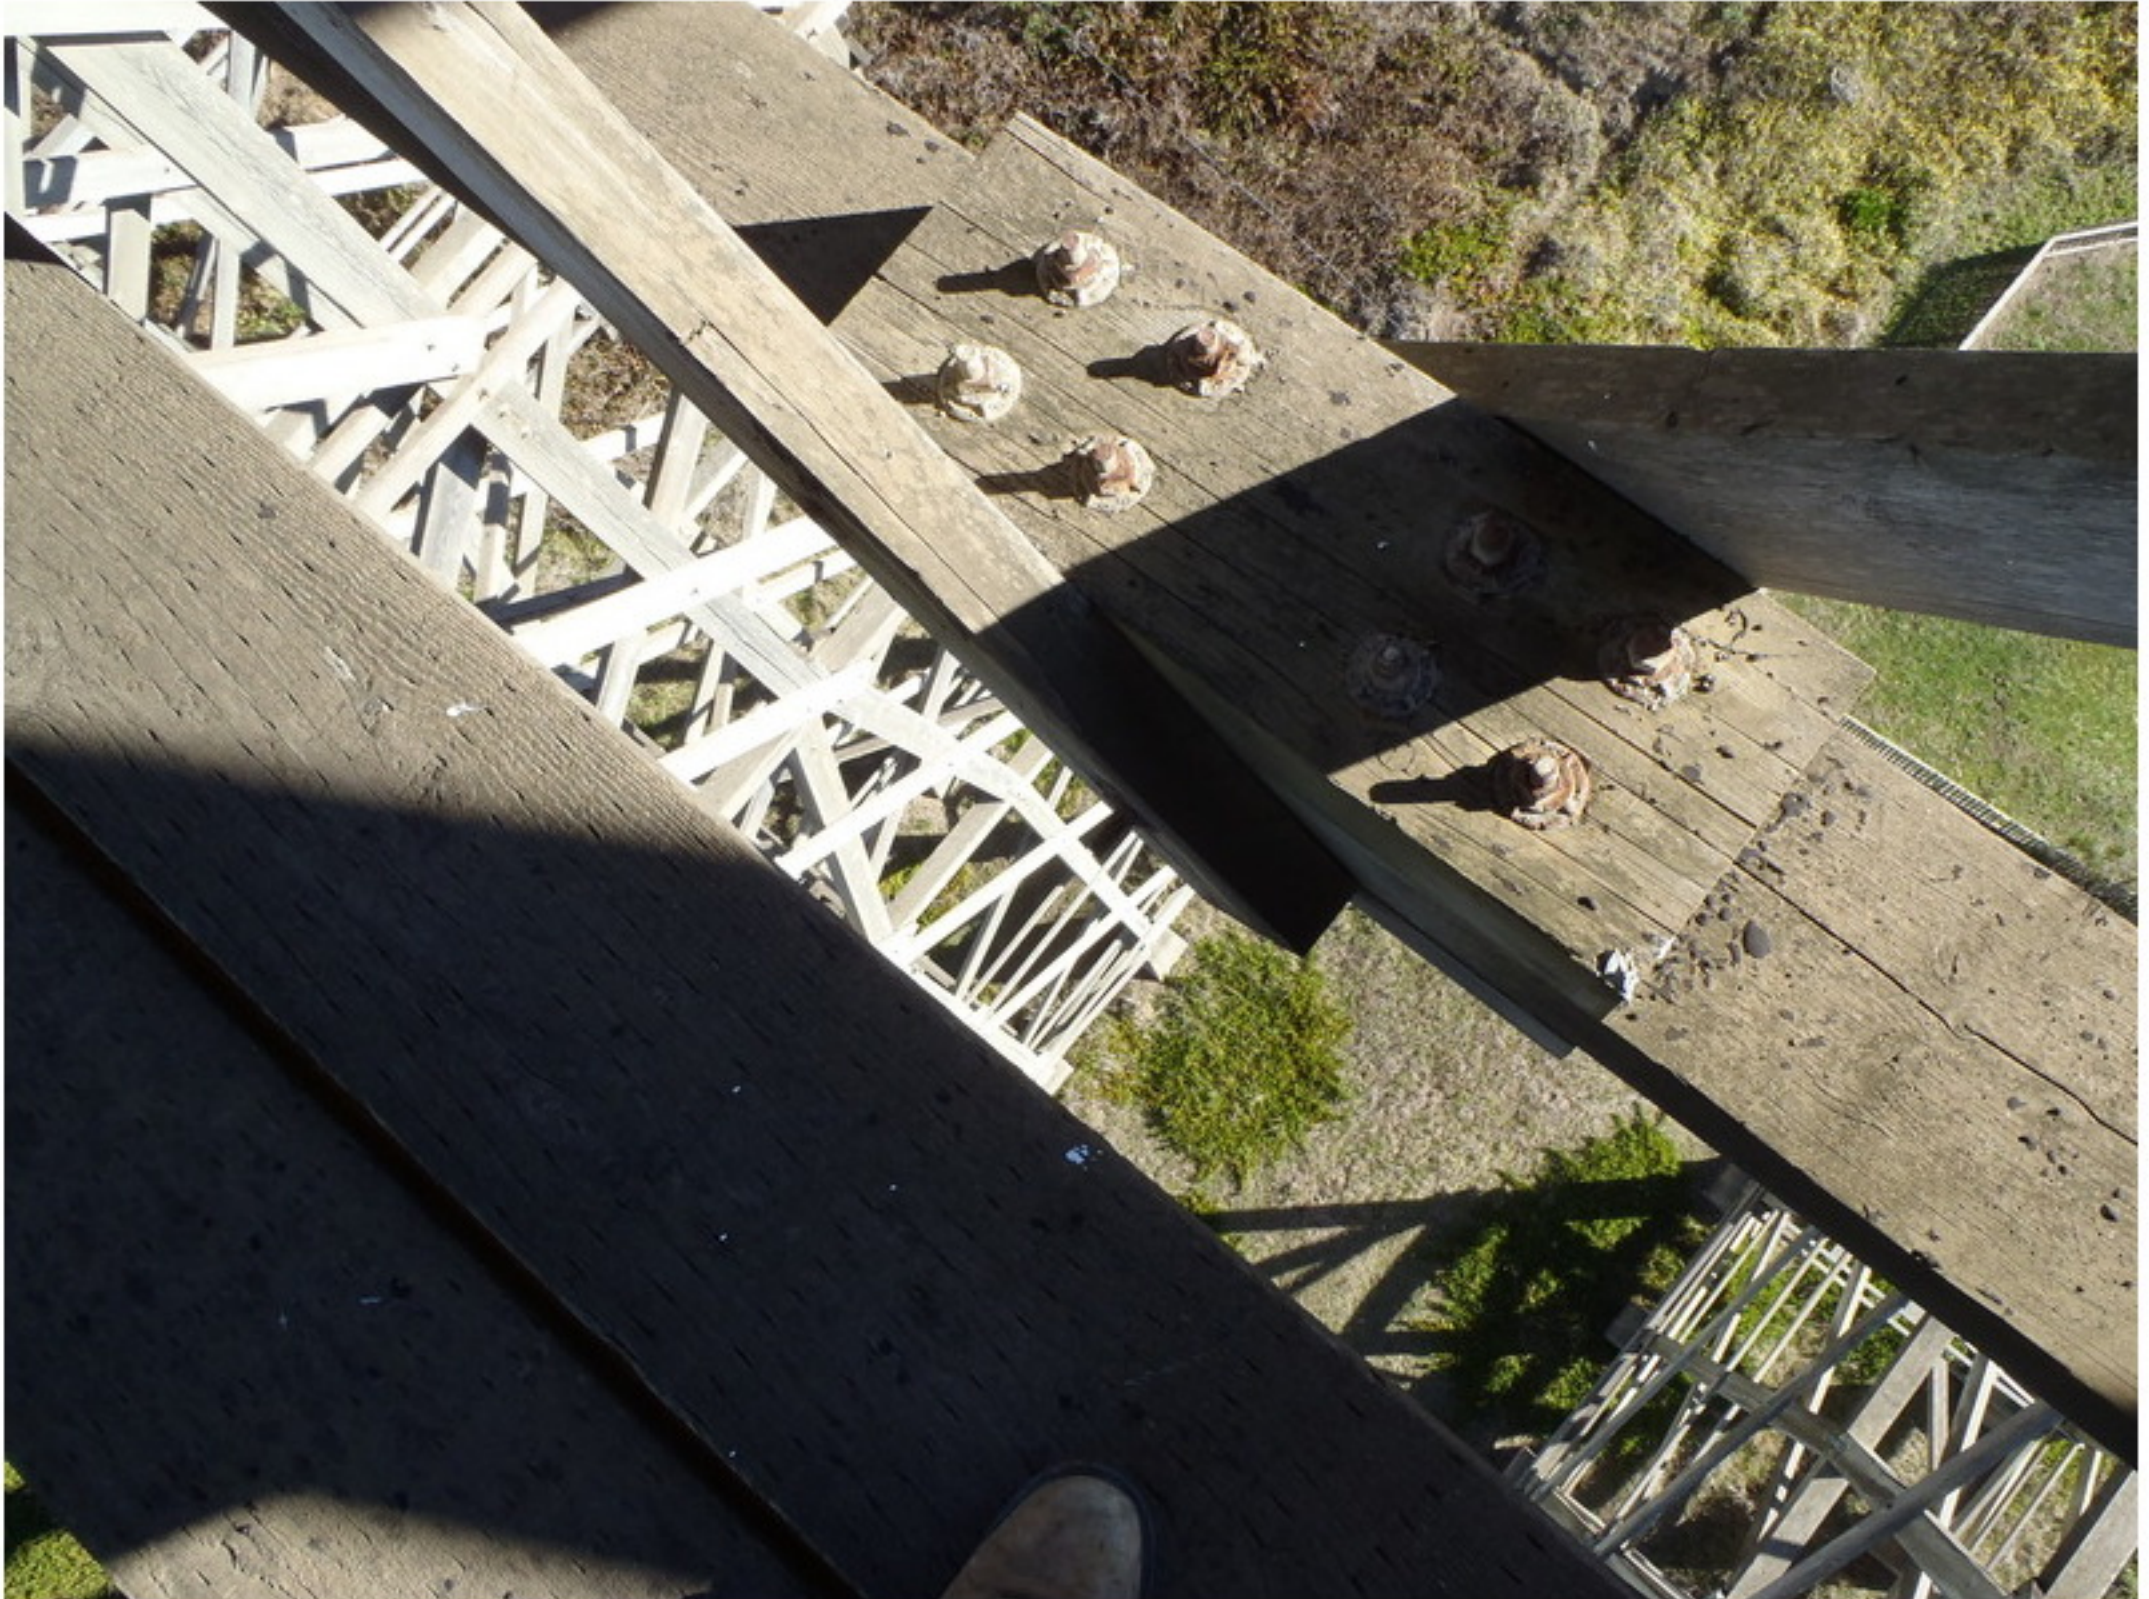
Photo No. 8
Looking down at mid-point of beam in Span 24 - half of the nuts are severely corroded

Continue the ongoing program of replacement of timber fasteners. Remove and replace the bolted connections and hardware (threaded rods, malleys, nuts, splice plates/straps, scabs, etc.) throughout the entire timber sub-structure.

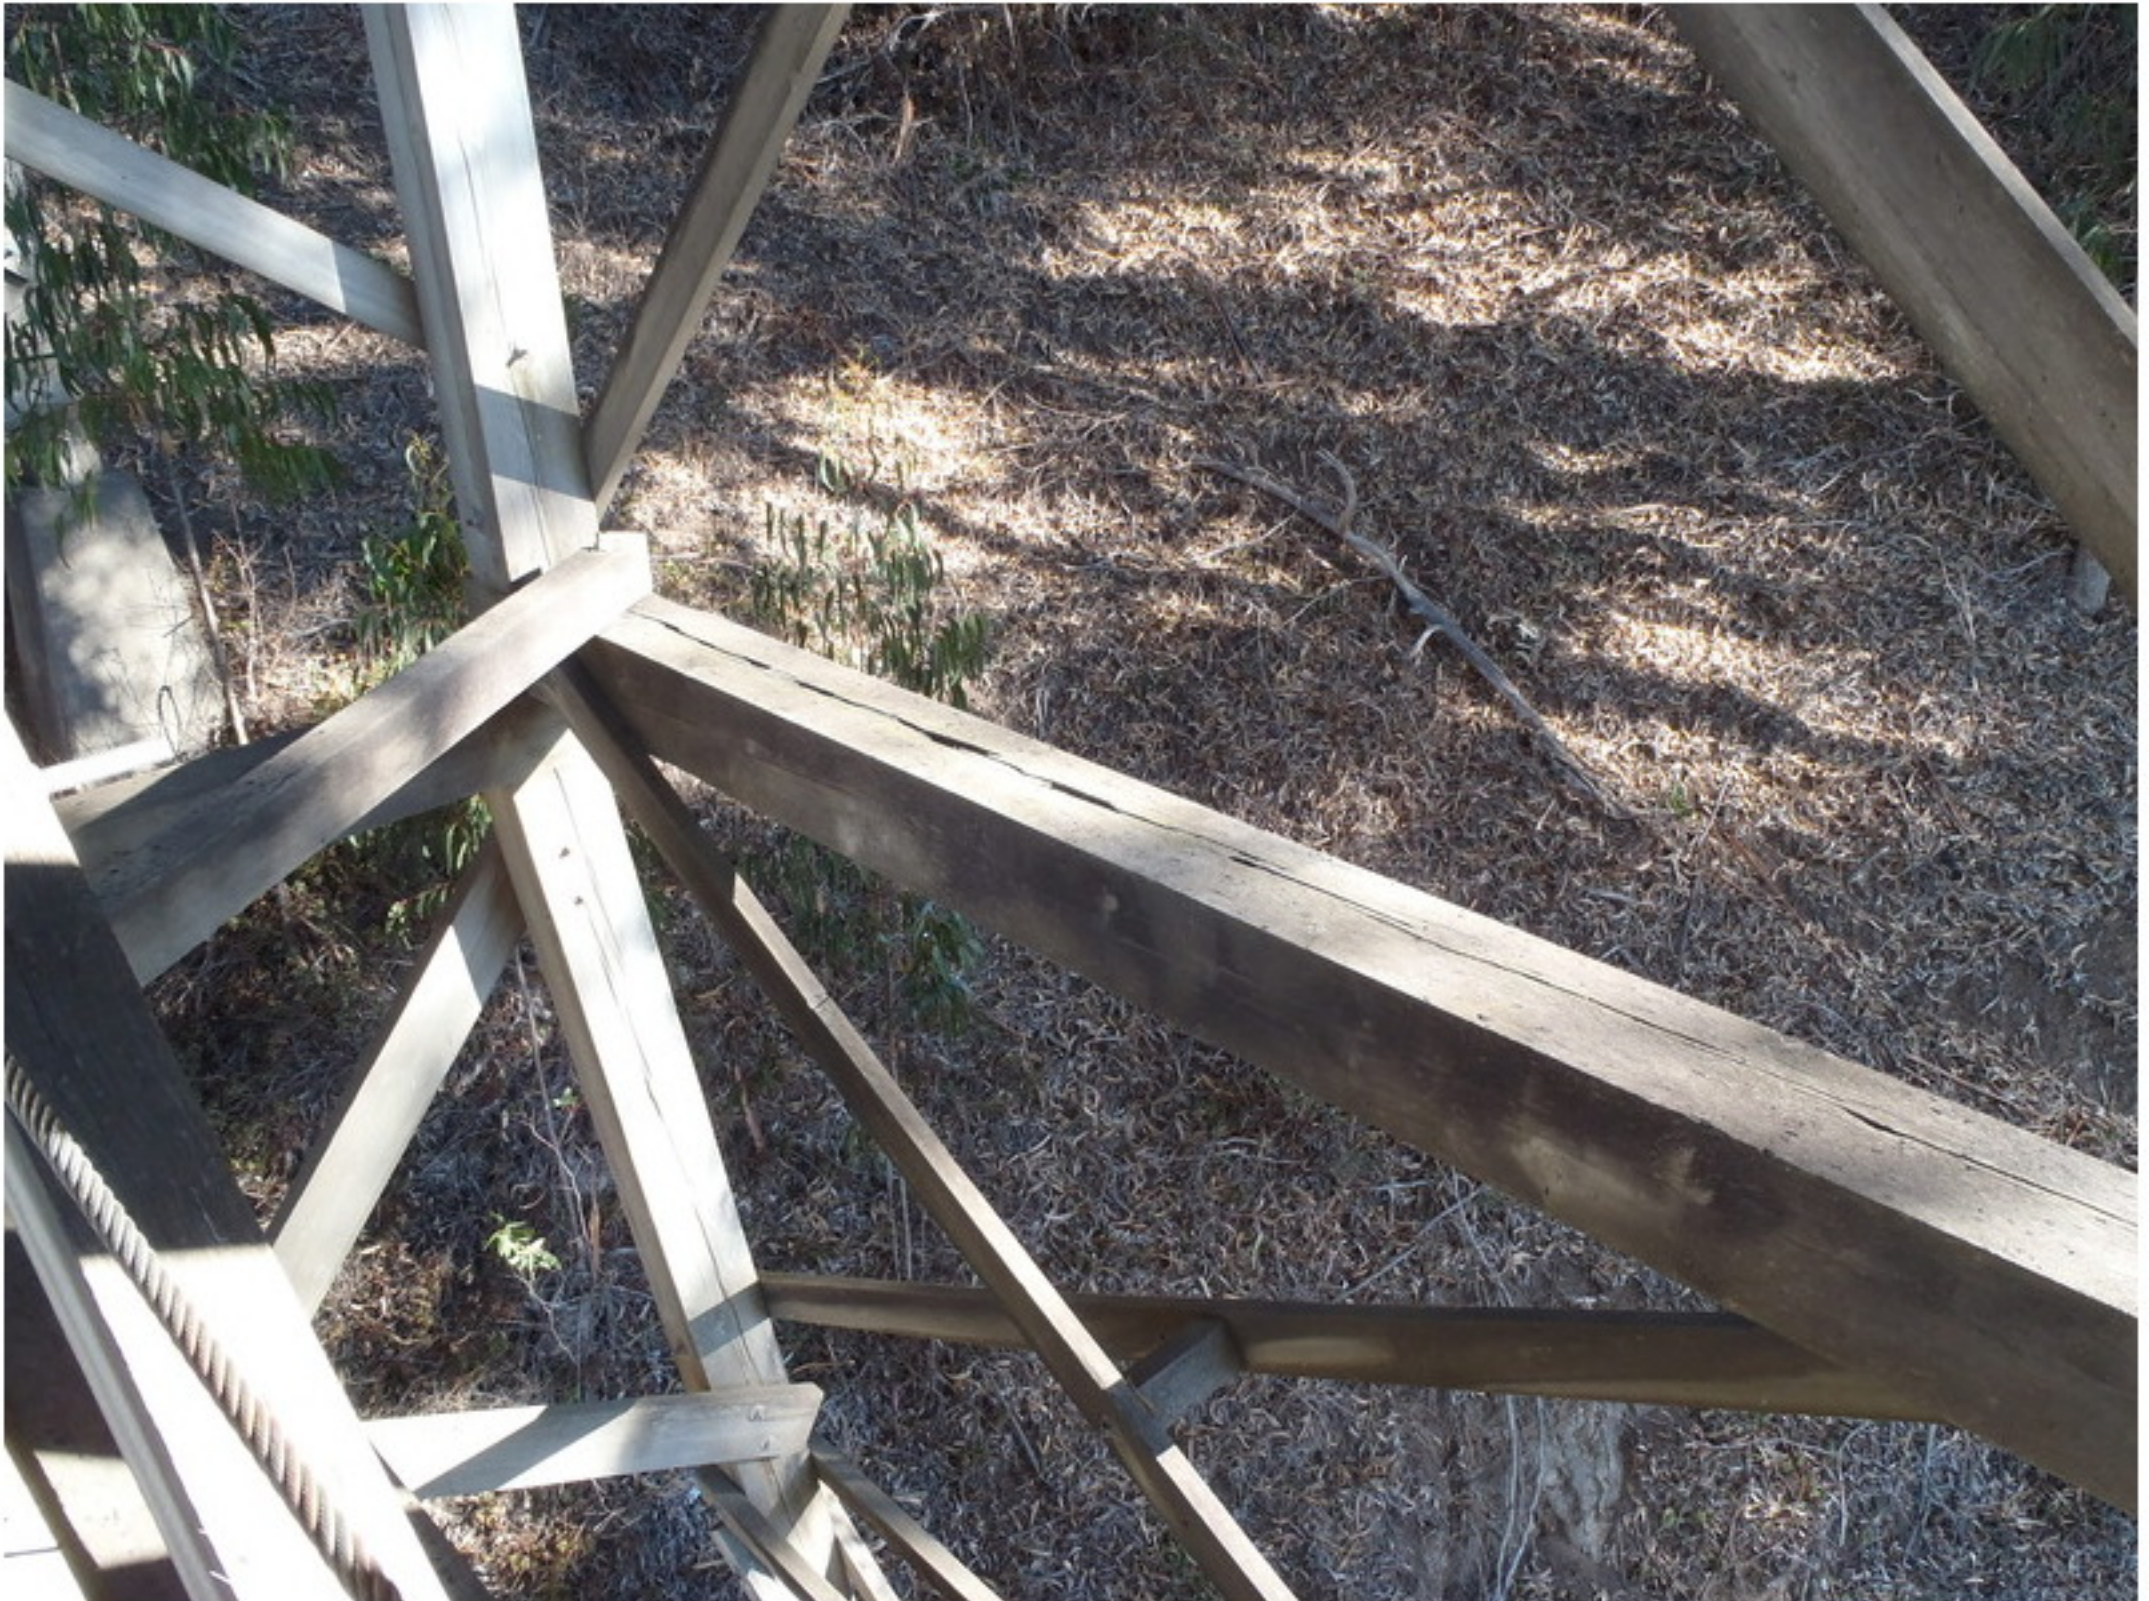
Photo No. 9

Looking over at beam in Span 31 adjacent to Bent 32 - core rot in horizontal member

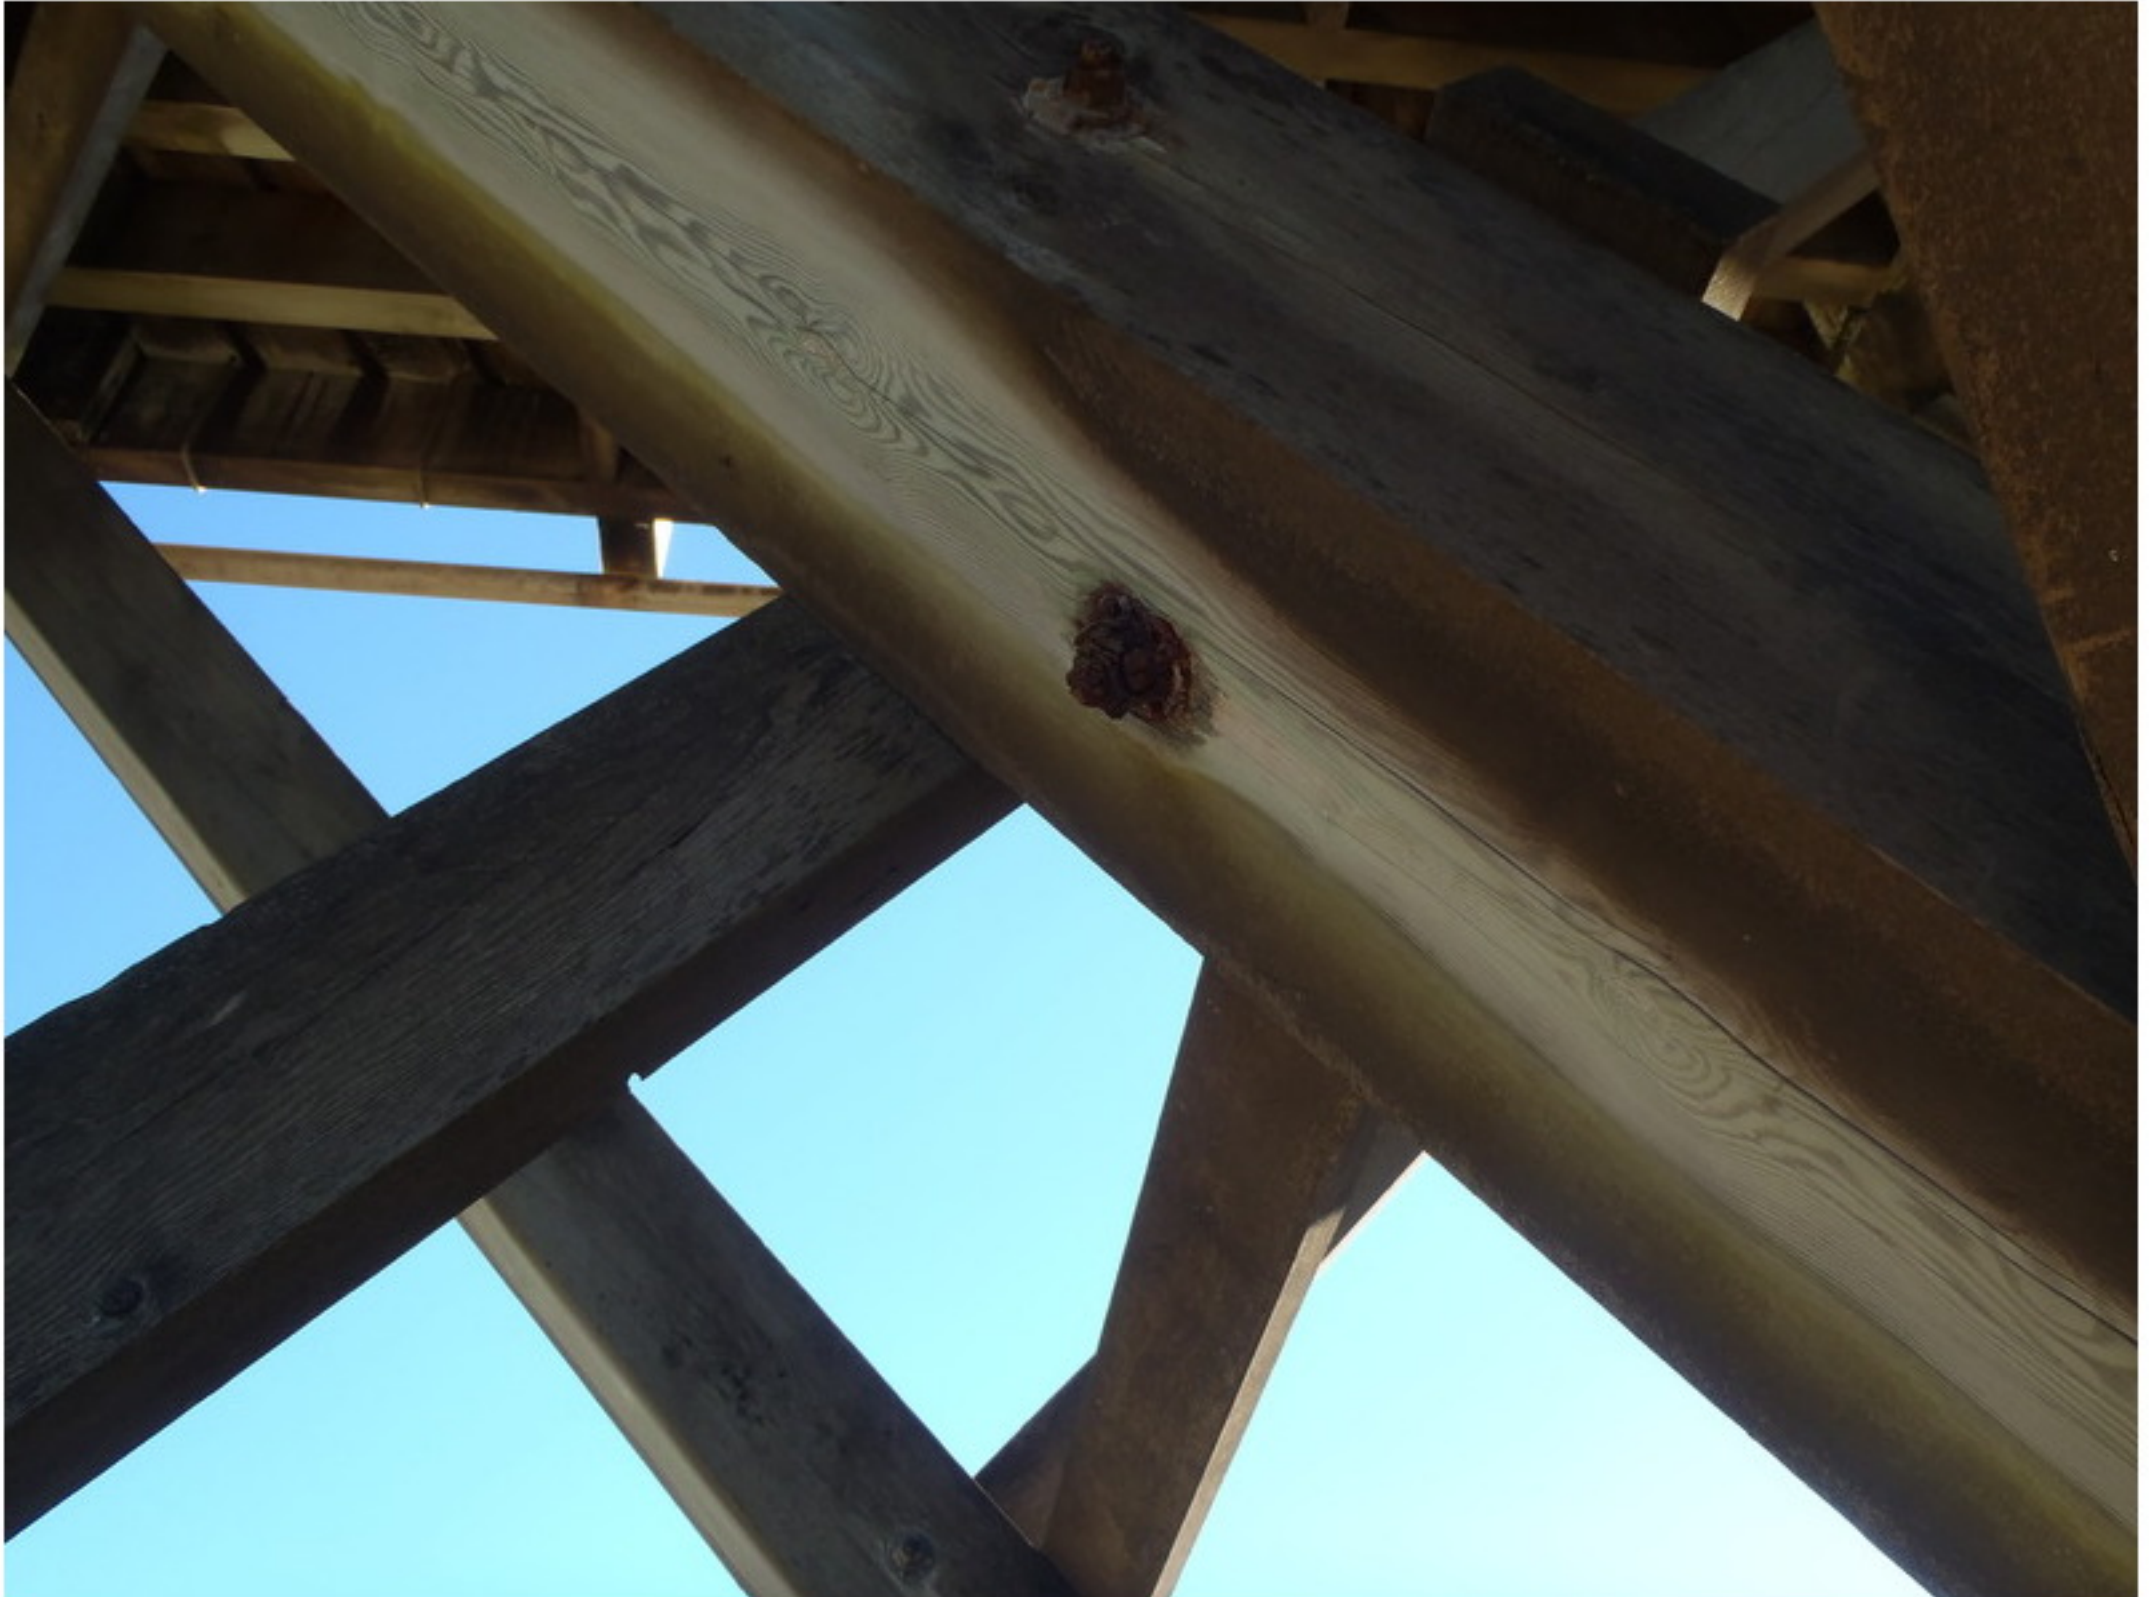
Photo No. 10
Looking up at bolted connection in Span 14- nut is severely corroded

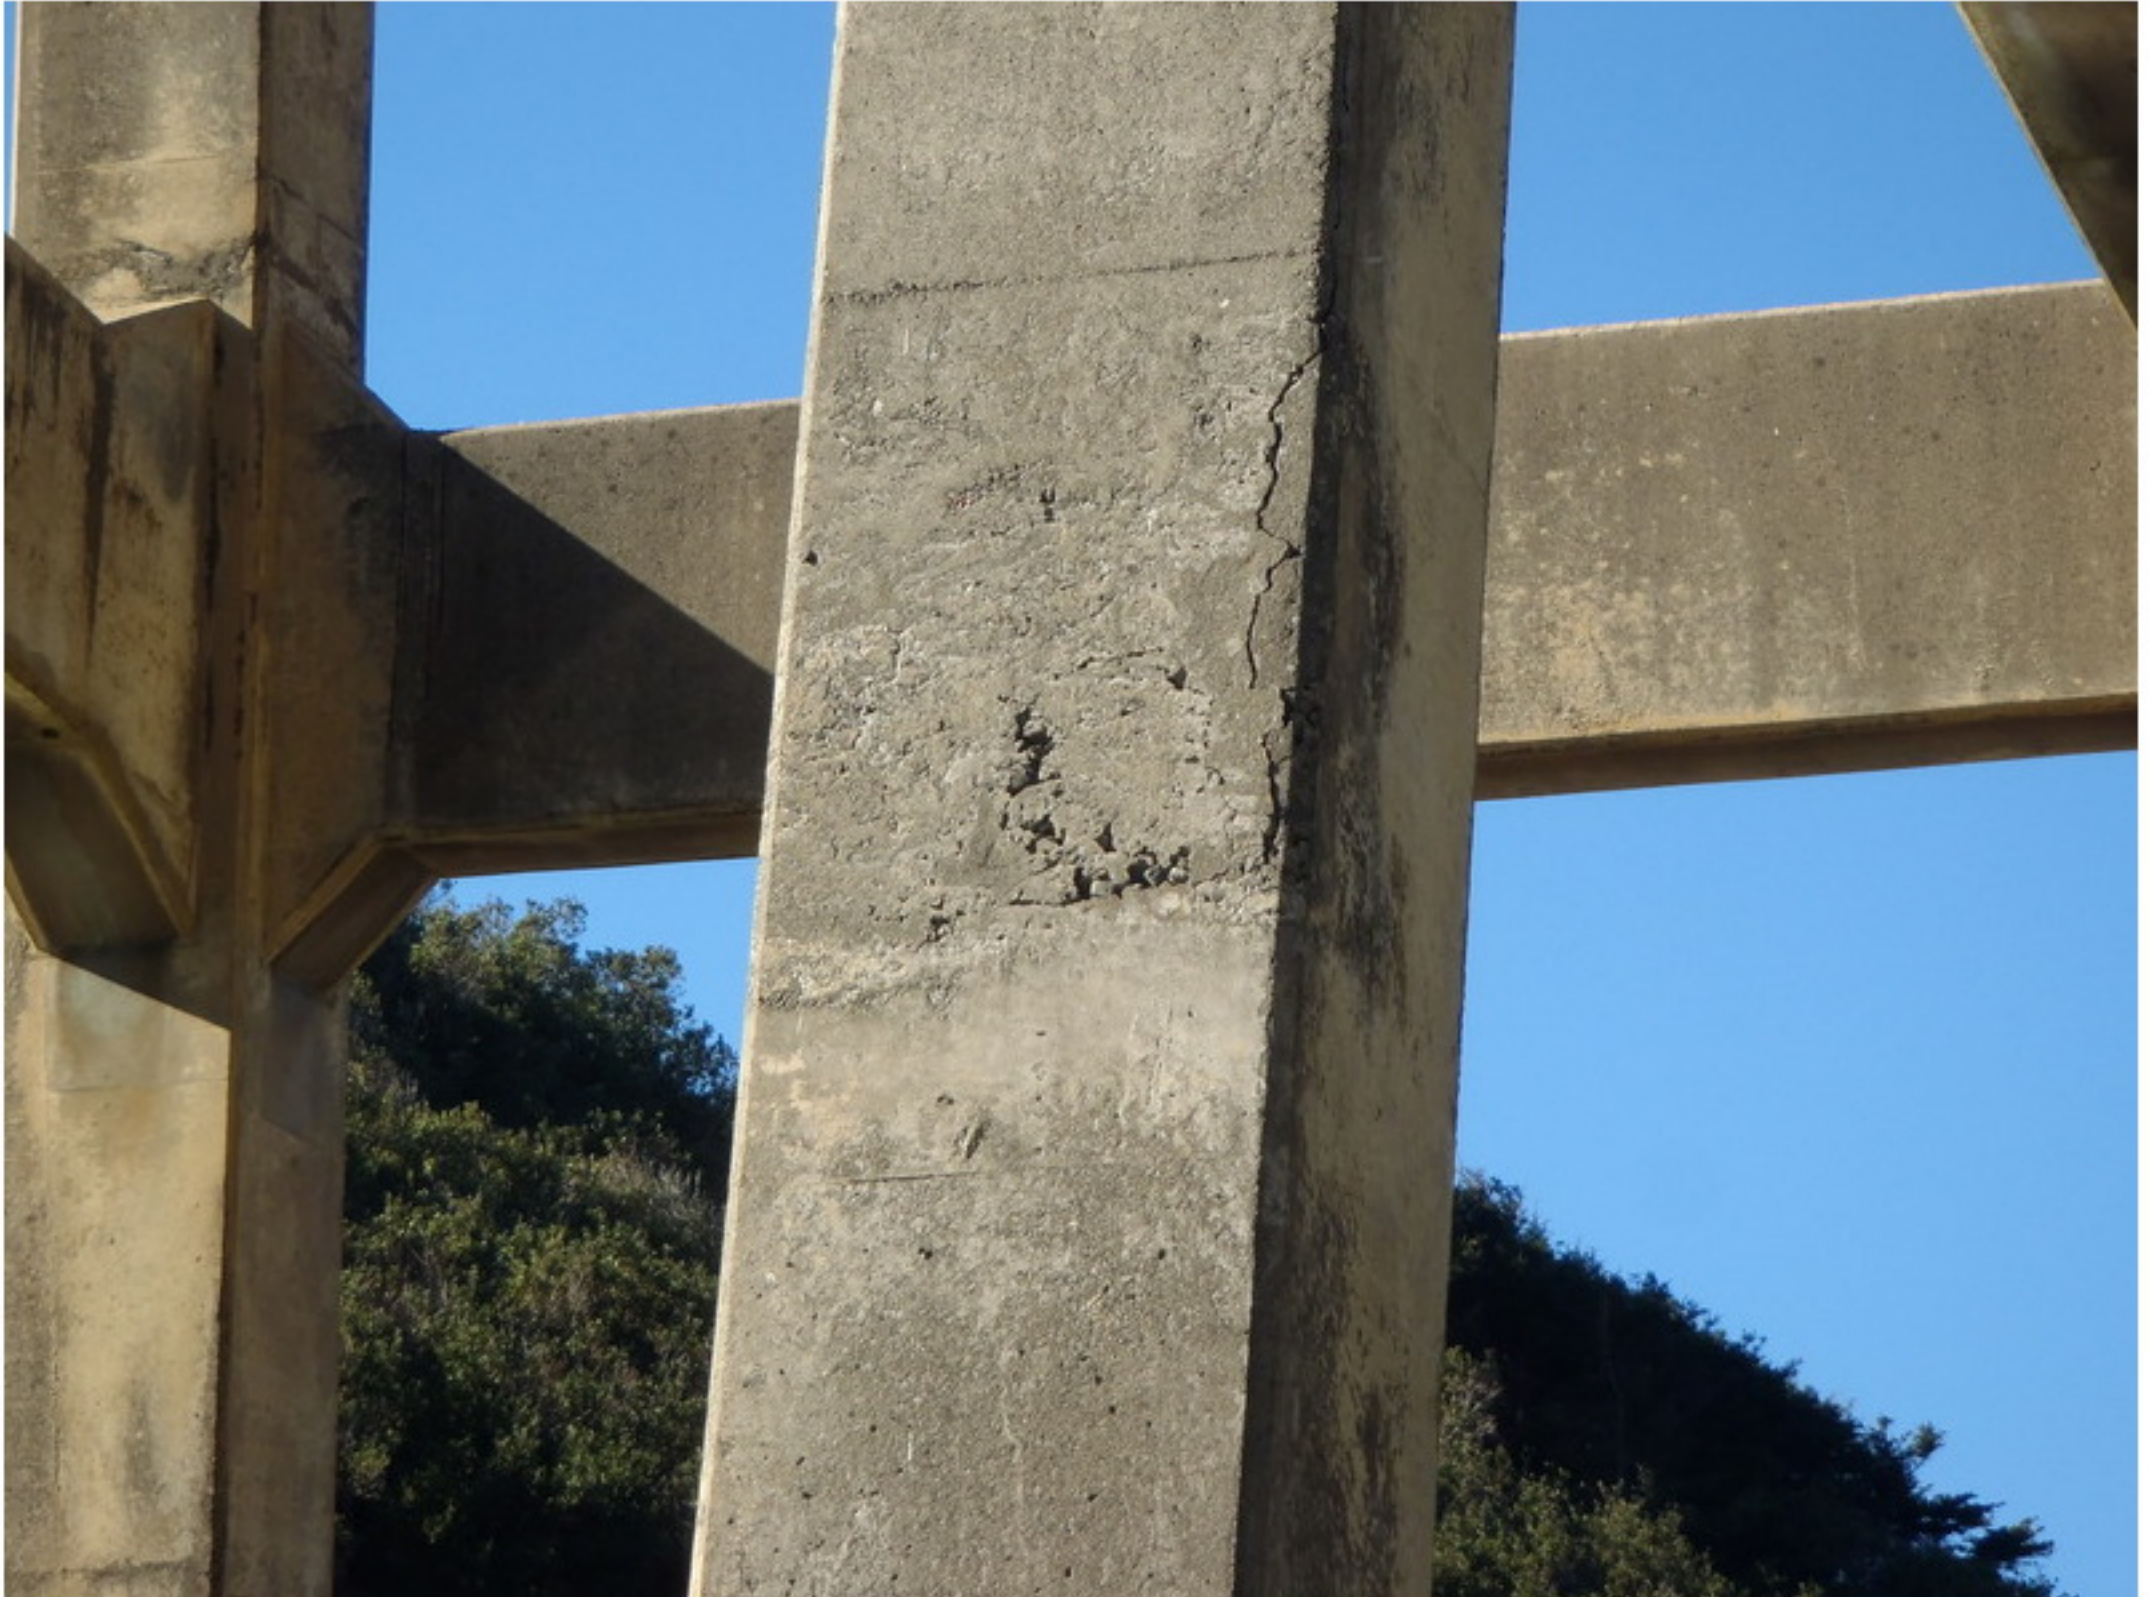
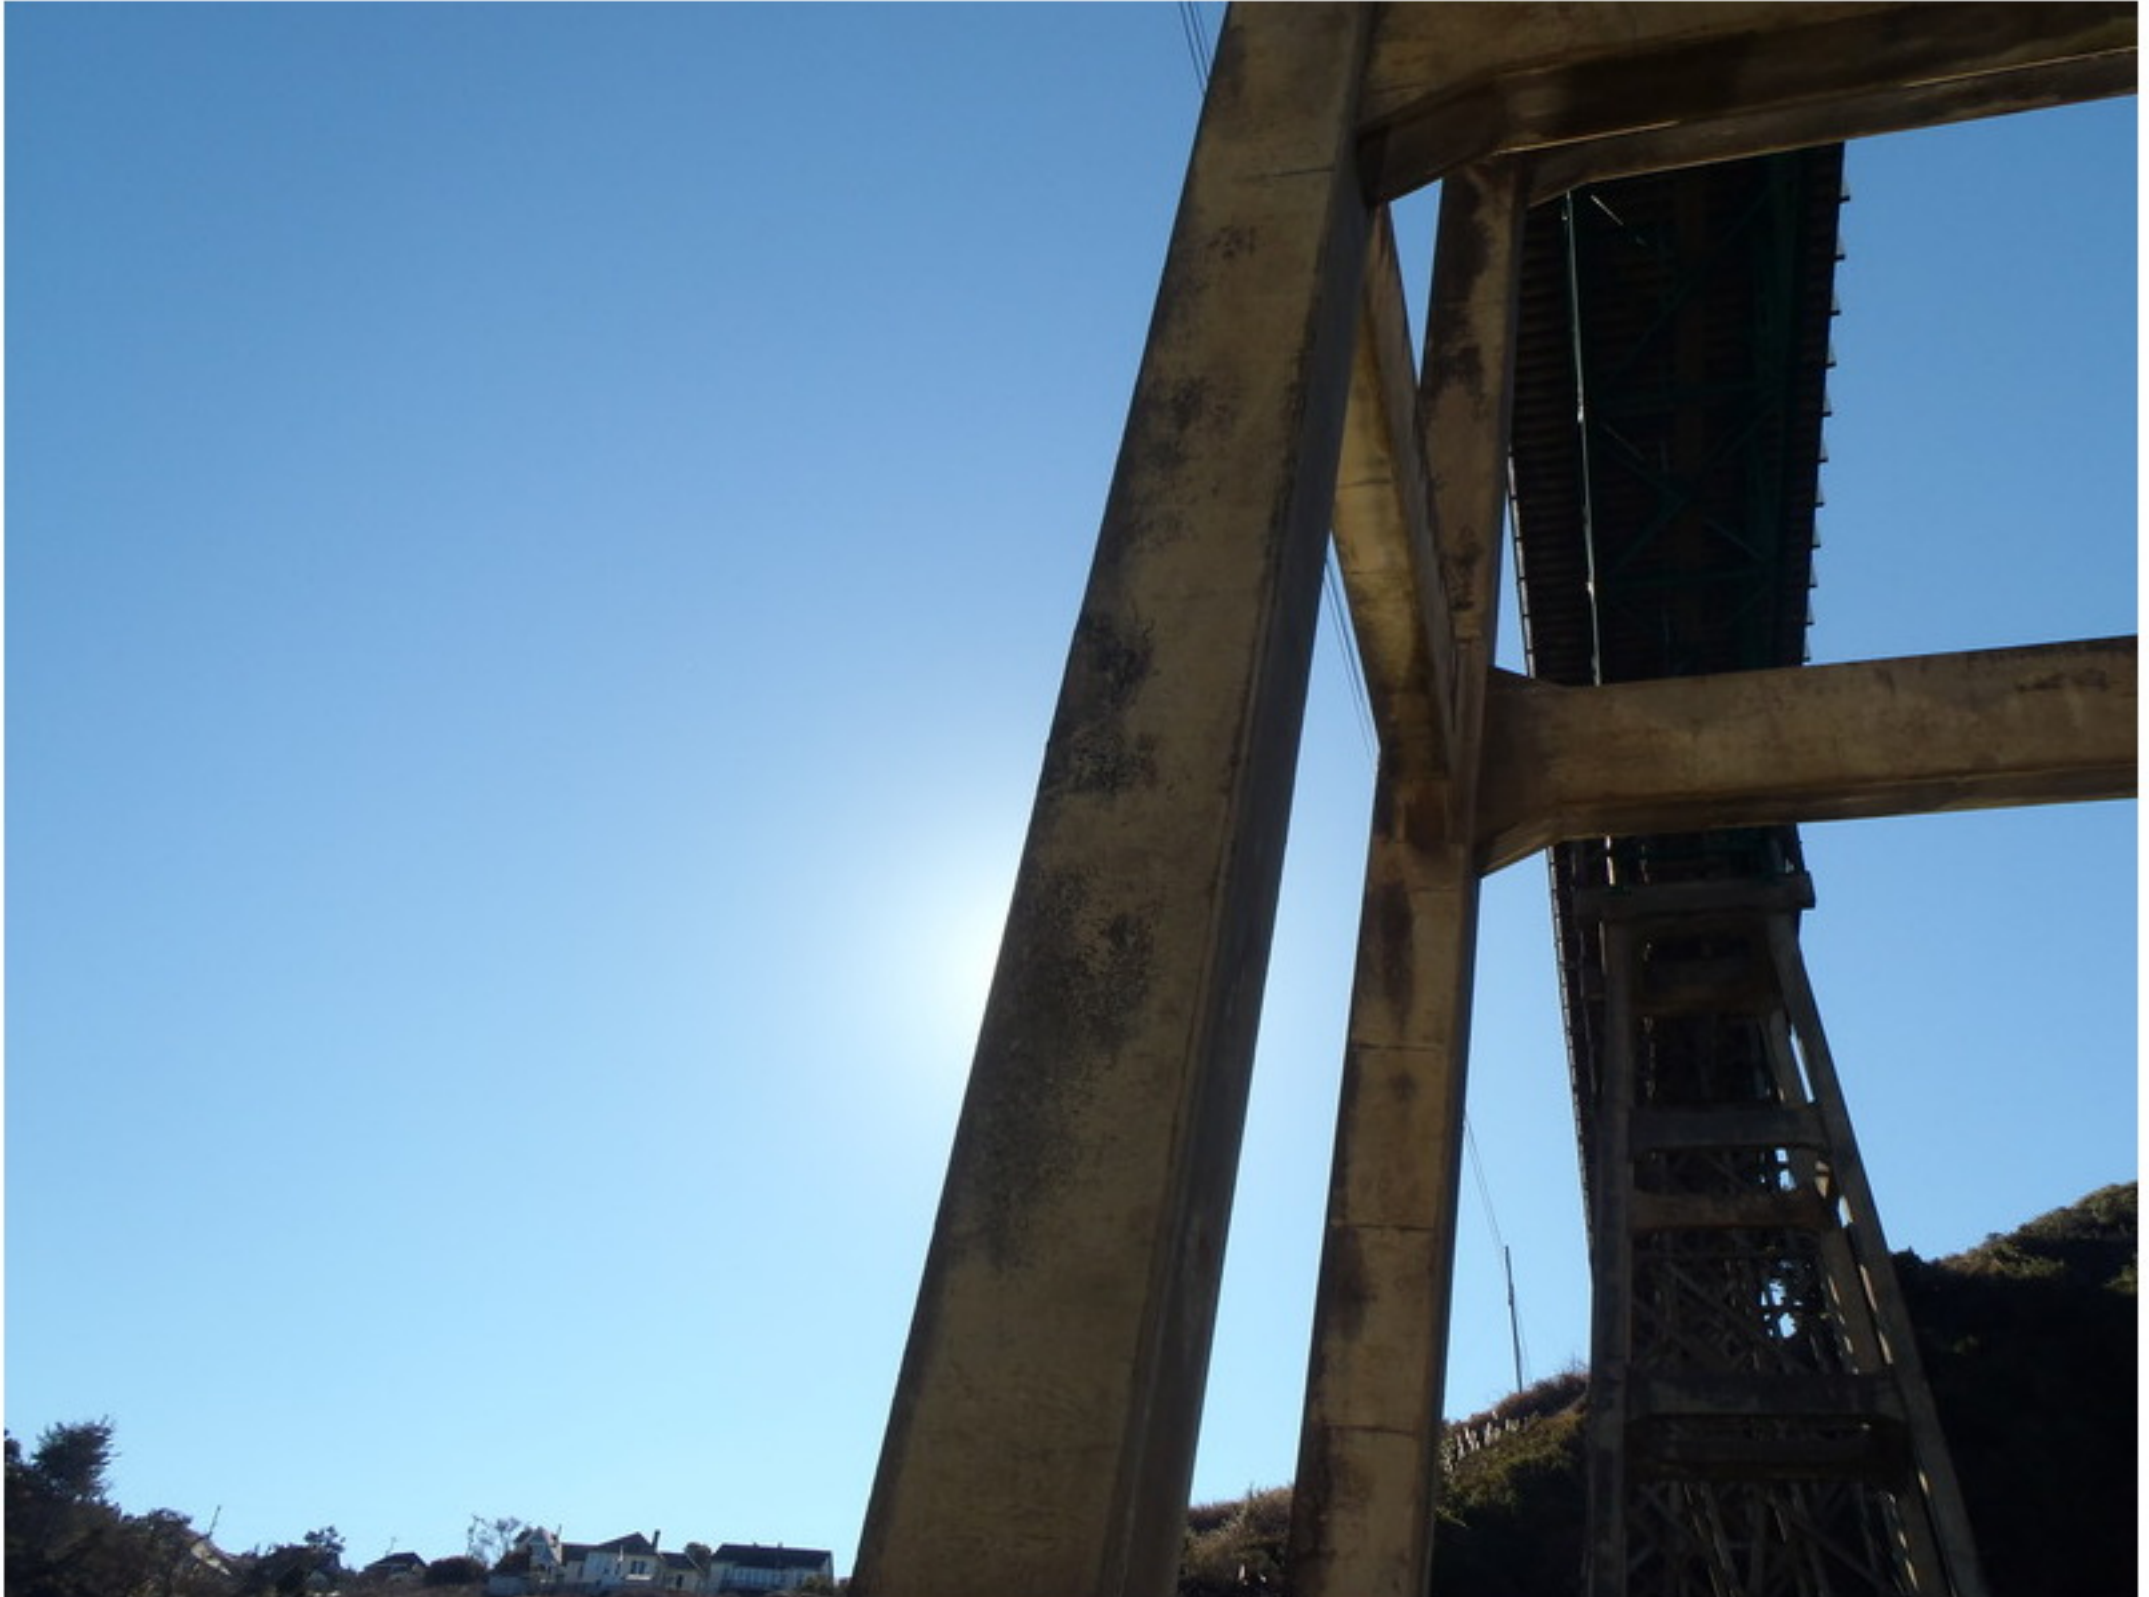
Column 2 in Bent 14, the north half of the north concrete tower, has an incipient spall along its northeast corner. The spall is located about 20 feet above the ground, and measures about 24 inches tall by 12 inches wide.

Photo No. 11
Looking up at incipient spall about 20 feet up at northeast corner of Column 2 in Bent 14

Looking up at incipient spall about 20 feet up at northeast corner of Column 2 in Bent 14

Repair Column 2 in Bent 14, the north half of the north concrete tower, where there is an incipient spall along its northeast corner. The spall is located about 20 feet above the ground, and measures about 24 inches tall by 12 inches wide.
